The Train 7 Fire at PETRONAS' LNG Complex, Bintulu, Malaysia

Norrazak Hj. Ismail, MLNG Tiga Sdn Bhd, PETRONAS and Thomas Roy Stuart, Foster Wheeler Energy Ltd, Malaysia

A major fire occurred in 2003 in the exhaust system of the propane compressor gas turbine in the first train (train 7) of the MLNG Tiga project. The authors describe the consequences of the accident, the analysis of the causes, the management of the plant recovery process, and the re-design of the system in both train 7 and train 8 to ensure enhanced integrity and increased safety.

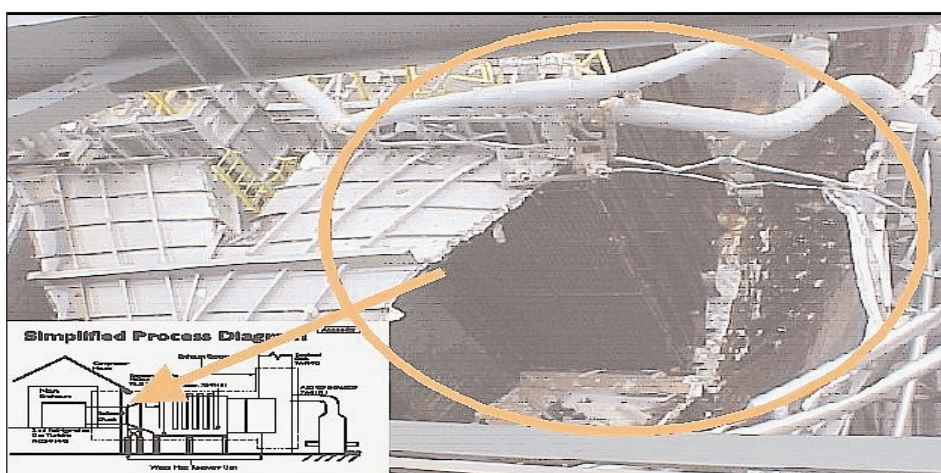
- The WHRU ducting was damaged beyond repair
- The hot oil coils were damaged beyond repair
- The regeneration coils were recoverable
- The gas turbine plenum was extensively damaged
- The housing around the compressor / turbine was extensively damaged
- The compressor was undamaged but needed to be stripped down for examination
- The turbine moved on its base but only sustained damage to ancillary equipment. It required disassembly for internal inspections
- The building suffered superficial damage
- No injury occurred to any personnel.

Figure 2: Top View of MLNG Tiga C3 GT Exhaust Plenum Damage

Train 7 was involved in a fire incident (Figure 2). It occurred on 16 August 2003 at 22:21 hours and led to a temporary shutdown of the train. After thorough investigation and analysis, appointed teams identified the specific damages that had occurred and developed a step-by-step recovery process to ensure that the Train 7 could resume operation quickly and safely.

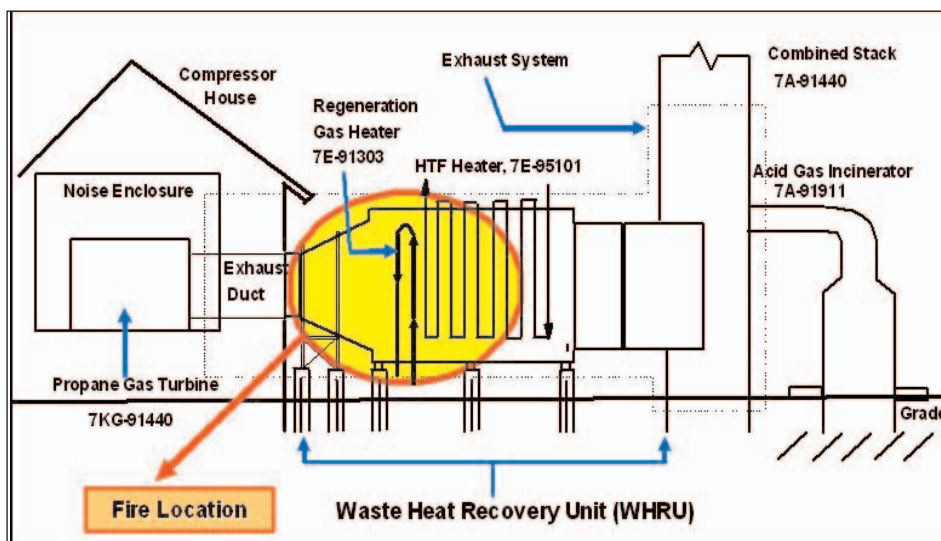
the exhausts of the main turbine drivers of the refrigeration compressors. Hot oil for general heating duties and hot natural gas for regeneration of dryers recover the exhaust heat with the use of heat exchanger coils. The exhaust gas from the C₃ GT passes through an exhaust plenum and then splits in a Y piece to enter the two halves of the Waste Heat Recovery Unit (WHRU). Each half contains a regeneration gas coil and 5 hot oil coils. A schematic of the arrangement is shown in Figure 3.

The regeneration coil has an inlet and outlet header with 32 tubes connecting them, each tube with a U bend at the top. The entire regeneration coil, including the headers, is housed within the WHRU duct. Under normal operation, the duct, which is refractory lined, reaches temperatures in excess of 500 °C.

Figure 3: Side View of MLNG Tiga C3 GT, WHRU, Exhaust System, and Incinerator

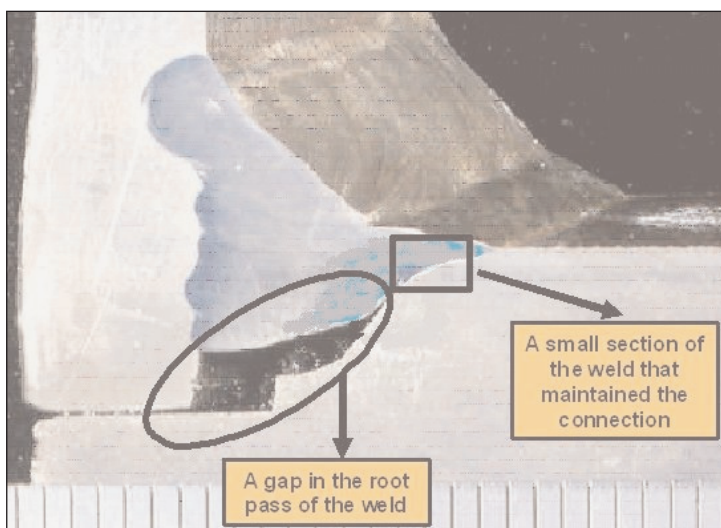
As soon as access was possible to the regeneration coil, the crack between the tube and header was observed and extensive studies conducted into the design of the coil. During normal operation the coil undergoes several heating and cooling cycles per day and high stresses occur. However, the area where the failure happened has relatively low stress factors.

A section of the coil was sent to The Welding Institute in the United Kingdom for analysis. The tube to header joint was sectioned and examined. It could be clearly seen from a connection adjacent to the failed weld that the root pass had not been carried out correctly. Several other such joints were examined and found to be poorly welded. The failed weld connection was maintained by a very small section of weld that was sufficient to withstand hydrostatic pressure test but not the cyclic stresses induced during operation as shown in Figure 4. This type of weld cannot be fully tested using radiographs, whilst Ultrasonic Testing (UT) is not suitable for use with incolloy material. The inadequacy of the weld could have been determined during the inspection of the root weld.

Figure 4: Cross Sectionalised between the Tube and Header of the Original Weld

The inspection plan for the regeneration coil was adequate but due to the complexity of the weld details and the critical nature of the equipment, additional surveillance should have been carried out in the fabrication workshop. The redesign of the tube to header connection is vastly superior to the original design and facilitates the application of Non Destructive Examination (NDE) reducing the need for day-to-day surveillance.

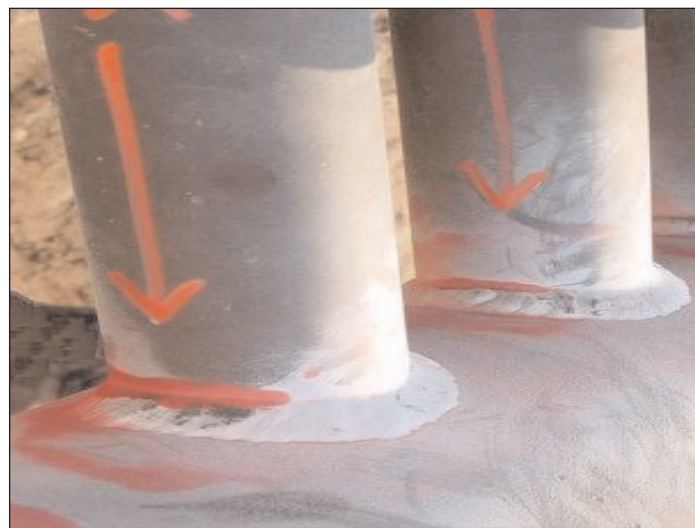
Figure 5: Original Welding Design between the Header and Tubes

The redesign team selected the use of nipolets between the header and tubes to allow easier welding and full radiographic testing of each joint. The original design of welding is shown in Figure 5 and the new design is shown in Figure 6. Additional springs were added to the coil supports to eliminate the high stresses experienced elsewhere in the coil (the U bend at the top of the coil).

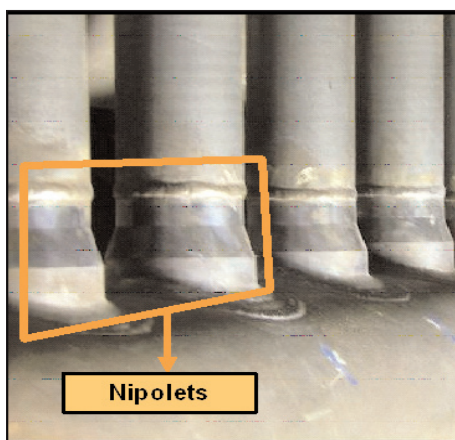
Figure 6: Improved Welding Design that use Nipolets between the Header and Tubes
