Eni JPDA 06-105	Company document identification 00177_DV_CD.HSE.0206.000_01	Owner document identification	Rev. index.		Sheet of sheets
			Validity Status	Rev. No.	
			CD	01

ROV Survey Reports

KITAN-1 EXPLORATION DRILLING: ROV ENVIRONMENTAL SURVEY REPORT

KITAN-2 EXPLORATION DRILLING ROV ENVIRONMENTAL SURVEY

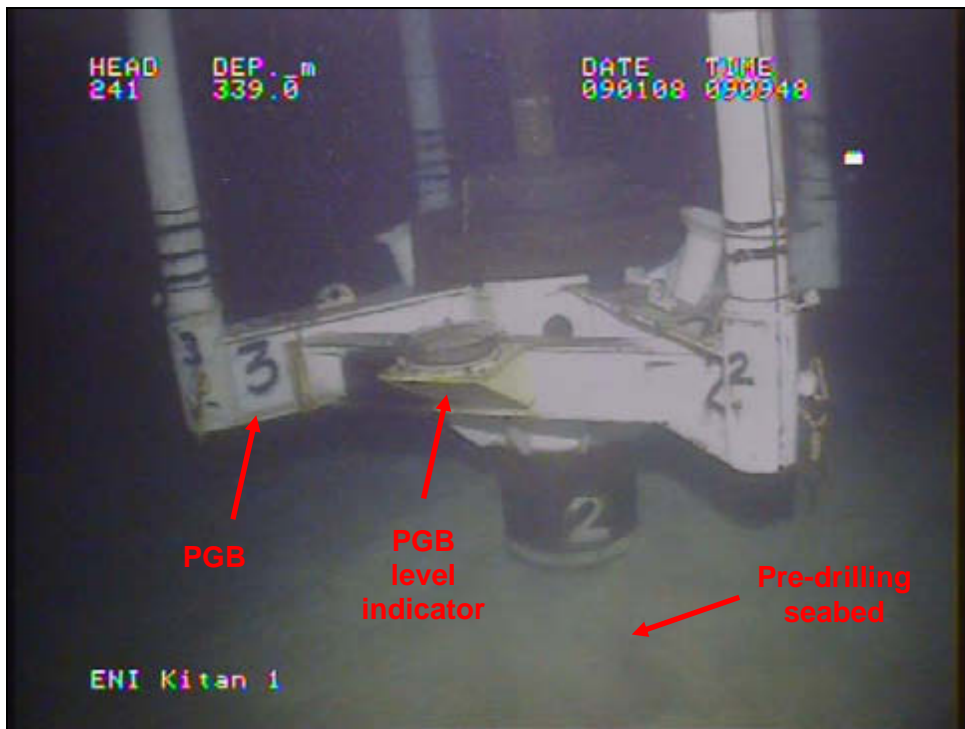
Figure 3.1: View of PGB prior to drilling, showing the base of the PGB approximately 2m above the pre-drilling (natural) sediment surface

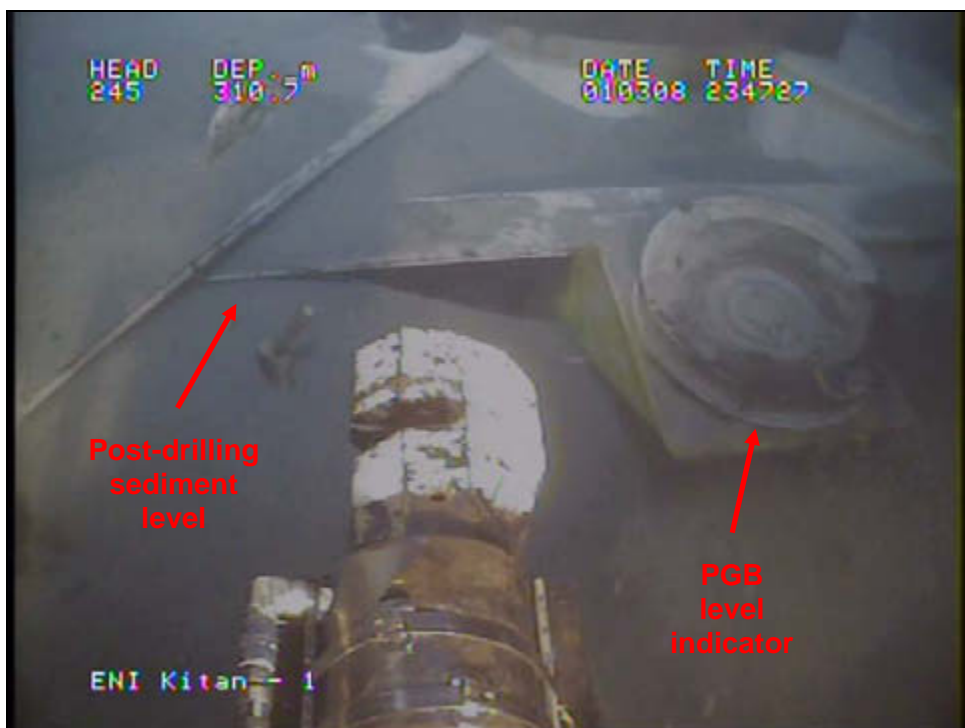
Water depth at the well head, as measured by the ROV's depth gauge, ranged between approximately 309m and 310.7m, compared with the general water depth of between 311m and 313m measured at 50m from the well head. This differential in water depth suggested that a cuttings mound of approximately two metres in height surrounded the well head. This was corroborated by the ROV Operator who commented during the survey that the pre-drilling (natural) seabed surface was approximately two metres below the bottom of the permanent guide base (PGB) (Figure 3.1), whereas was level with the PGB after drilling (Figure 3.2). The ROV Operator also reported that, earlier, the post-drilling sediments had been almost level with the top of the PGB guideposts, suggesting that a substantial quantity of cuttings had been quickly eroded and washed away.

Figure 3.2: View of PGB (upper background) showing sediments at or slightly covering its base

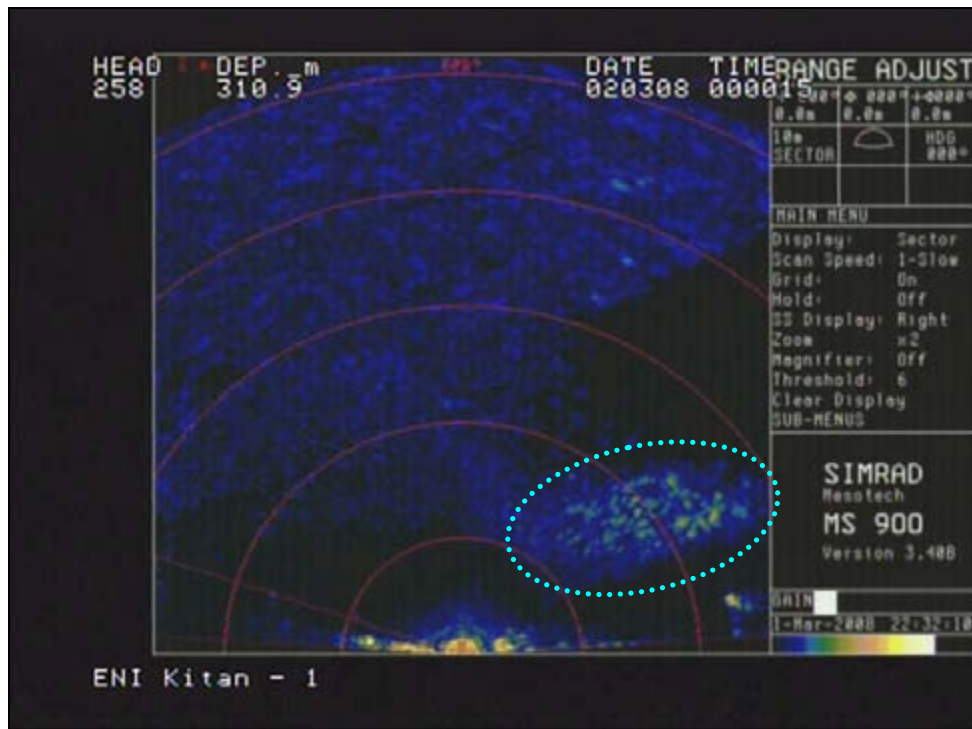
Sonar scans detected cuttings mounds to the northwest, southeast and northeast of the well head. On the west cardinal bearing, a cuttings mound of approximately 2m x 5m in area was detected at approximately 2m to the northwest of the well head (Figure 3.3). Scans at a range of 25m, 50m and 100m on this cardinal bearing confirmed that this was the only feature of note with no other cuttings mounds detected on this bearing.

Figure 3.3: Sonar scan on west cardinal bearing at 10m range (range rings are at 2m intervals). A cuttings mound to the northwest of the well head is indicated by the blue ellipse

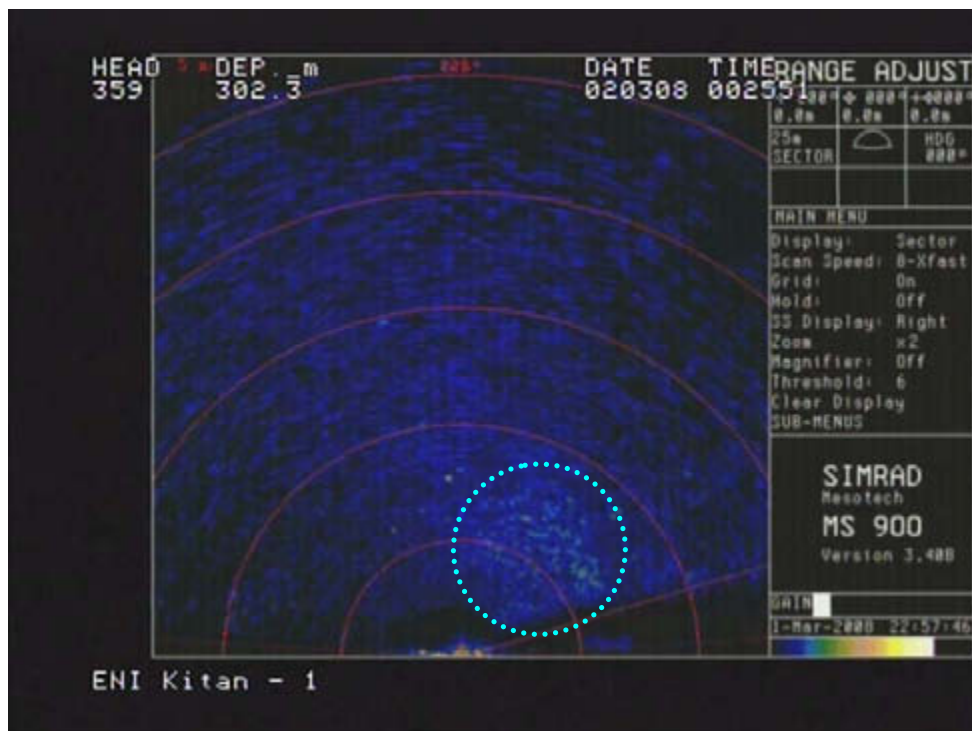
On the north cardinal bearing, a cuttings mound of approximately 5m x 5m was detected at 2m from the well head (Figure 3.4). This was the only feature of note on this cardinal bearing. On the east cardinal bearing, a cuttings mound of approximately 2m x 4m was detected at about 2m to the southeast of the well head (Figure 3.5). No cuttings mounds were detected on the south cardinal bearing.

Figure 3.4: Sonar scan on north cardinal bearing at 25m range (range rings are at 5m intervals). A cuttings mound to the northeast of the well head is indicated by the blue circle

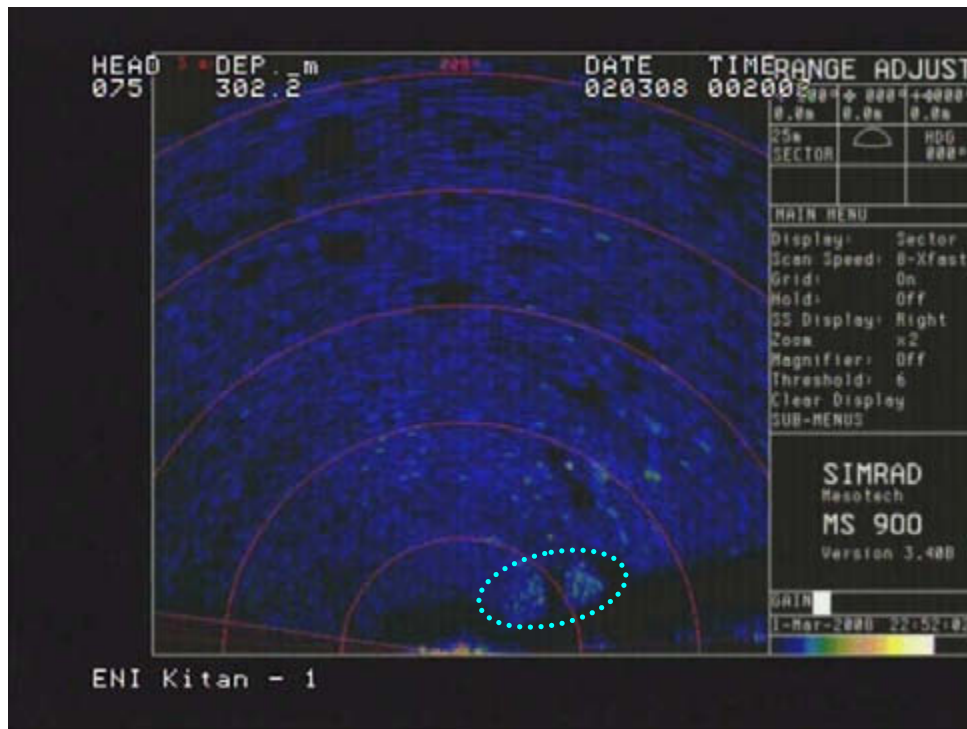
Figure 3.5: Sonar scan on east cardinal bearing at 25m range (range rings are at 5m intervals). A cuttings mound to the northeast of the well head is indicated by the blue ellipse

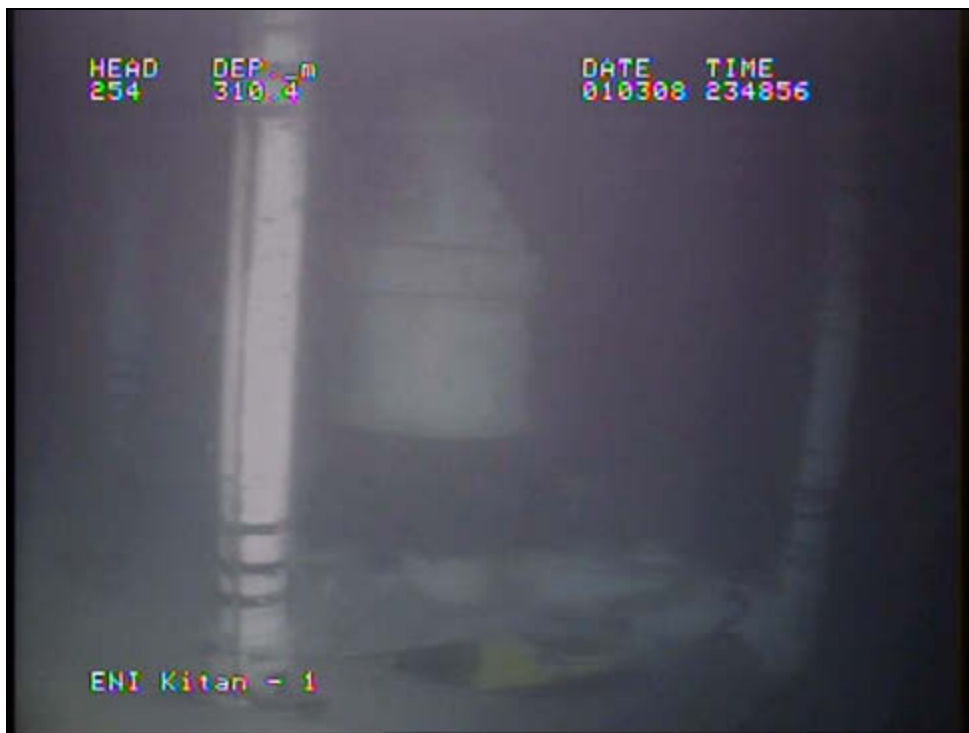
During the ROV survey, the well head and the seabed were clearly visible from several metres away (Figure 3.6). Thus, water turbidity was interpreted to be low (i.e. a high water clarity) especially because water depth was over 300m and the ROV was the only source of illumination. Crustaceans were abundant in the water column above the well head and were observed swimming across the field of view (Figure 3.7) possibly attracted by the ROV lights.

Figure 3.6: Well head clearly visible from several metres away

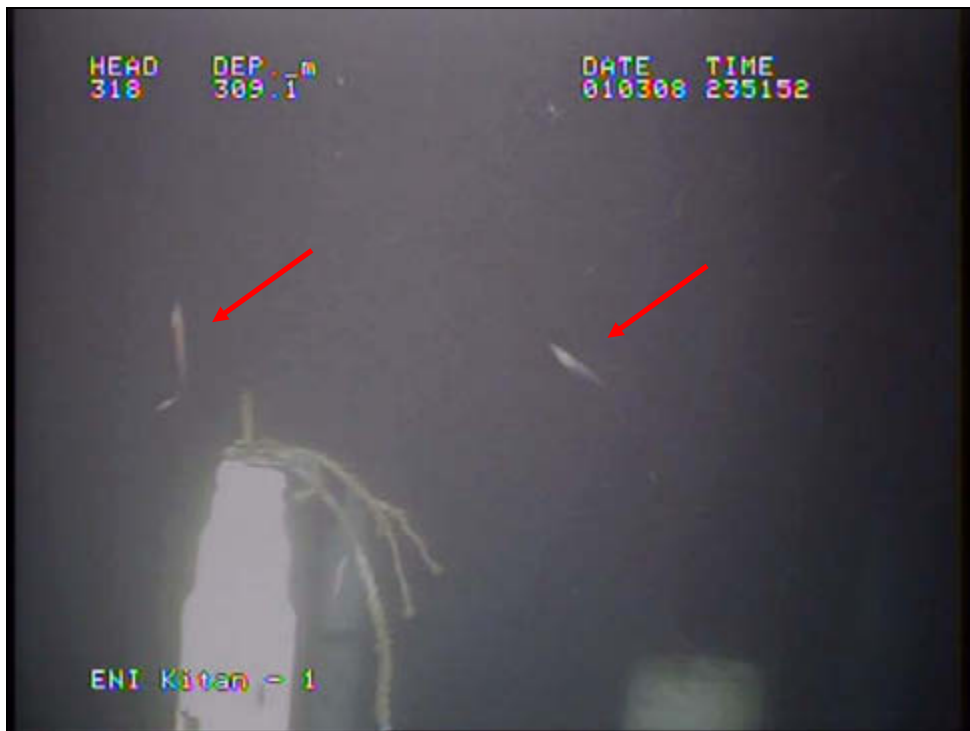
Figure 3.7: Typical view of crustaceans (marked with an arrow) swimming across the ROV's field-of-view above the well head

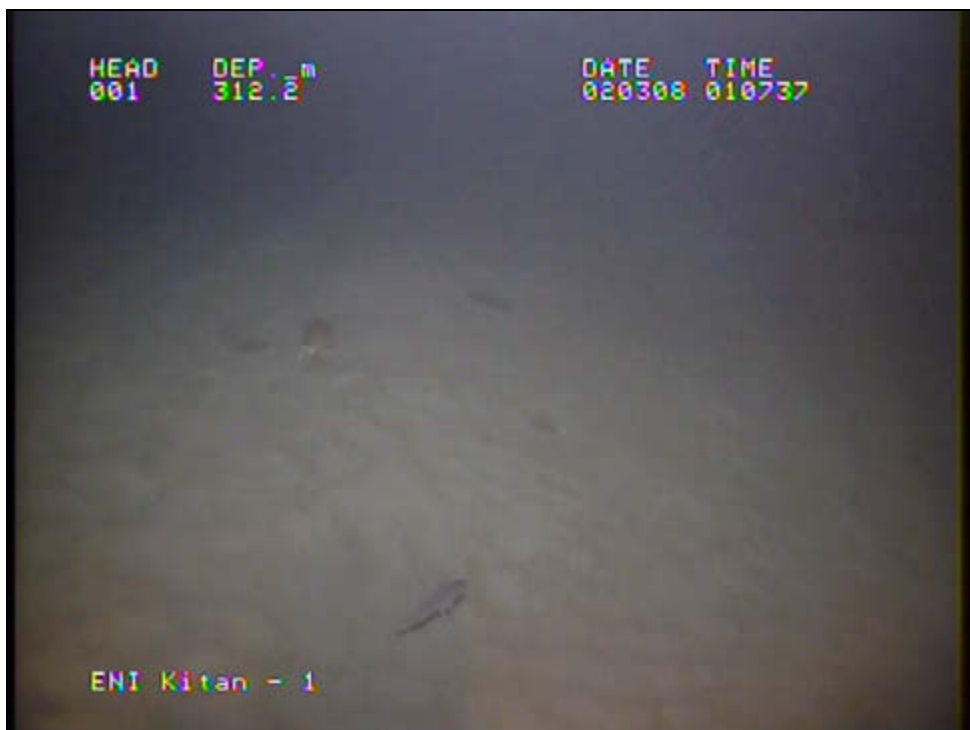
On each of the four 50m video transects, the seabed was observed to be a flat, featureless plain comprised of fine sediments. Infauna (animals inhabiting the seabed) were observed to be abundant as evidenced by burrows. Epibenthic fauna (living on or near the sediment surface) such as hermit crabs and fish were also common (Figure 3.8). Water turbidity was observed to be low, with the seabed generally clearly visible from several metres away throughout the length of each transect (with the exception of those occasions when the ROV unintentionally made contact with the seabed during the survey resulting in disturbance of the surface sediments).

Figure 3.8: Typical view of seabed surrounding Kitan-1 showing current-induced ripples, infauna burrows and epibenthic crabs and fish

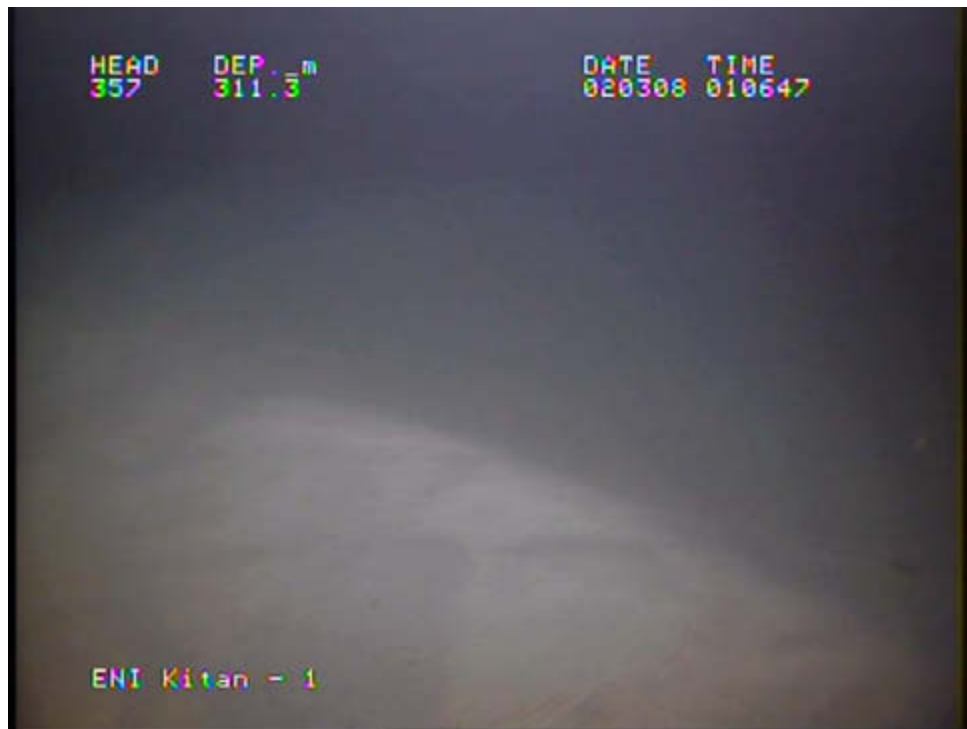
The ROV video confirmed the presence a cuttings mound located at approximately 2m from the wellhead and extending out for a further 5m (Figure 3.9). The water depth over this mound rose to approximately 303m at its shallowest point, suggesting a height of 8-10m above the surrounding seabed surface. The rippled seabed beyond the mound, such as that observed at approximately 13m from the well head (Figure 3.10), confirmed that the mound was relatively small. Hermit crabs and fish were observed at this location (Figure 3.10) suggesting that any impacts of drilling cuttings on infauna and epibenthos, such as smothering, were localised.

Figure 3.9: Cuttings mound located to the north of the Kitan-1 well head

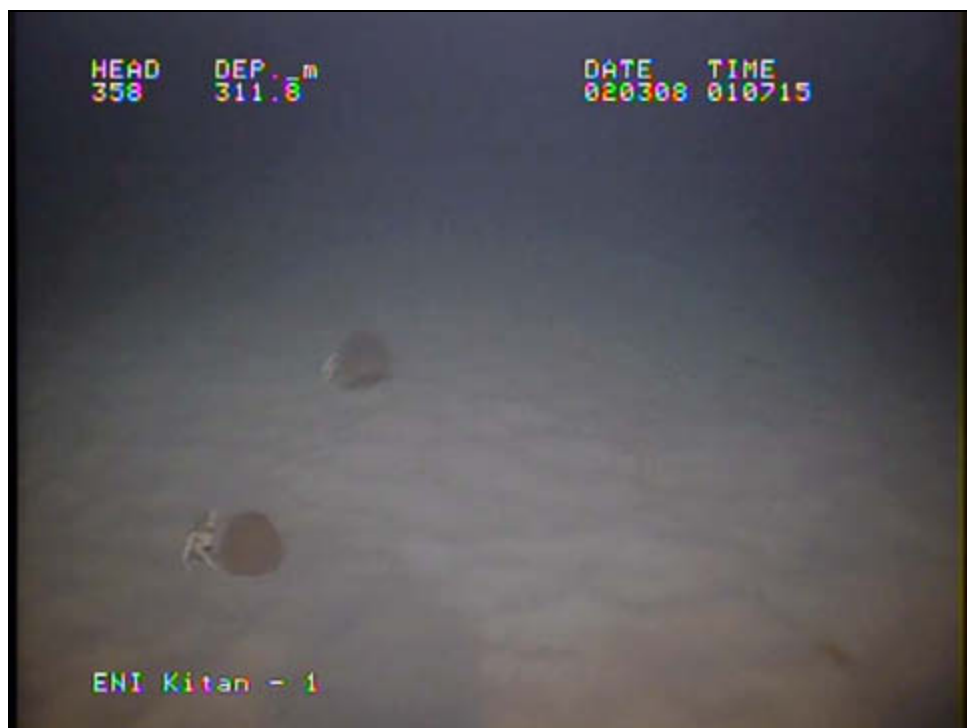
Figure 3.10: Rippled seabed and hermit crabs observed at approximately 14m north of the Kitan-1 well head, immediately north of a cuttings mound

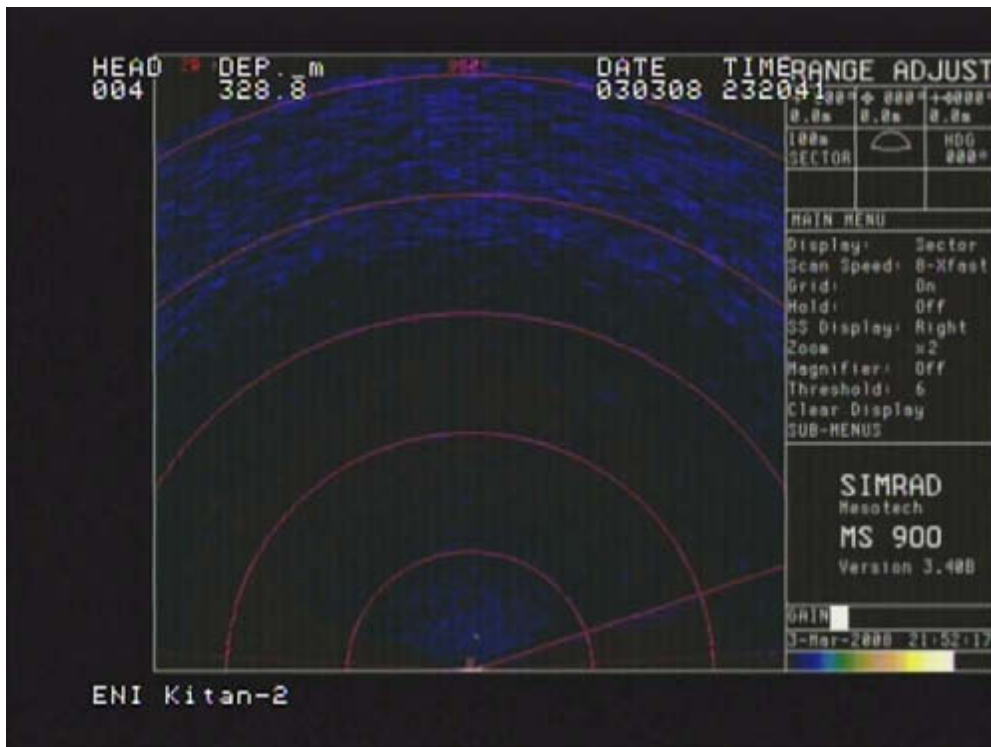
Prior to drilling, ROV sonar scans and visual surveys showed the seabed surrounding the Kitan-2 well to be a flat, featureless plain with no evidence of mounds or depressions (Figures 3.1 and 3.2). The seabed was generally comprised of fine sand and mud sediments with patches of shell sand material and cobble rubble (Figure 3.3). Water depth was approximately 328m.

Figure 3.1: Pre-drilling sonar scan on north cardinal bearing at 100m range (range rings are at 20m intervals) showing no evidence of seabed elevations

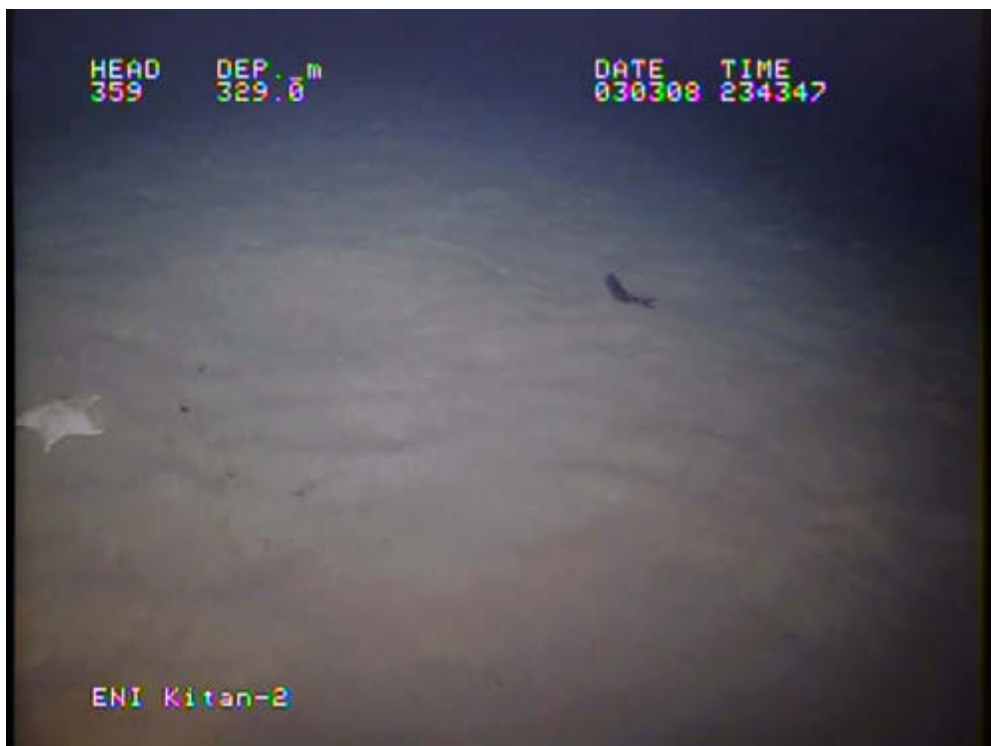
Figure 3.2: Typical view of seabed at Kitan-2 prior to drilling. A starfish and fish are visible

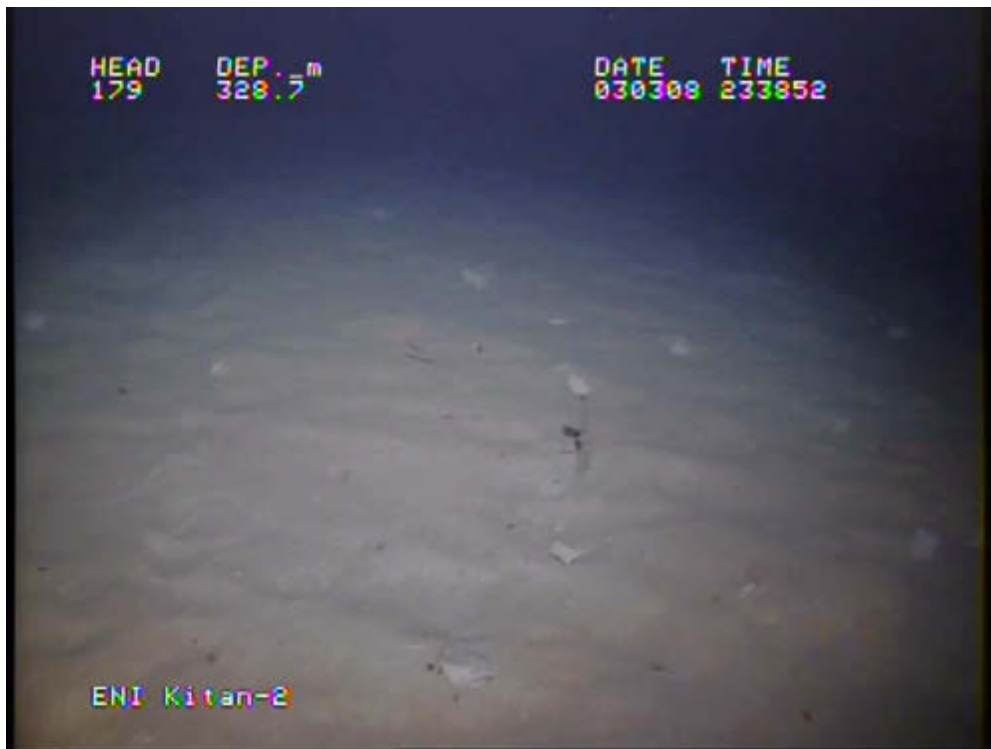
Figure 3.3: View of seabed north of Kitan-2 prior to drilling showing cobbles (probably coral rubble) scattered across the otherwise muddy seabed

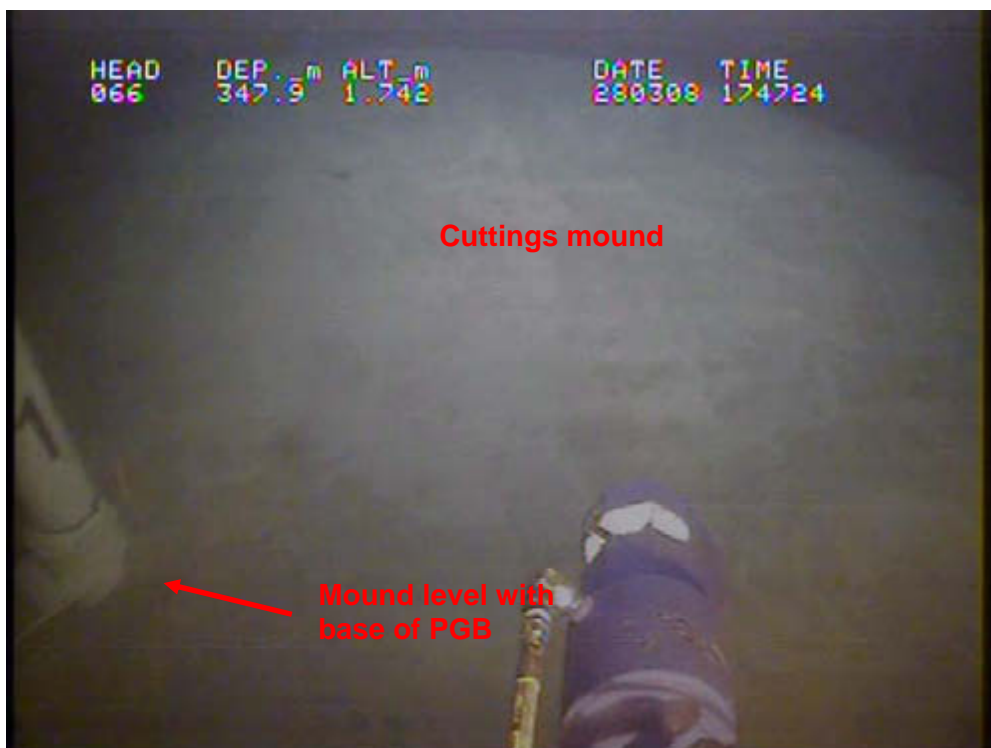
Post-drilling, there was a 2m high cuttings mound immediately surrounding the wellhead. Prior to drilling, the seabed surface was 2m below the permanent guide base (PGB) whereas after drilling, the seabed surface was level with the base of the PGB (Figure 3.4). Sonar scans to the north, east, south and west detecting cuttings mounds in all directions to up to 30m from the wellhead (Figures 3.5 – 3.8). The surface area of the cuttings mounds ranged from 180 square metres up to 390 square metres (Figures 3.5 – 3.8). The cuttings appeared to be approximately 2m in height (as observed immediately around the PGB) except for one mound to the west where the mound appeared to be up to 10m in height, based on observed variations in water depth measured using the ROV's depth gauge.

Figure 3.4: Cuttings mound level with the base of PGB (seabed was 2m below PGB prior to drilling)

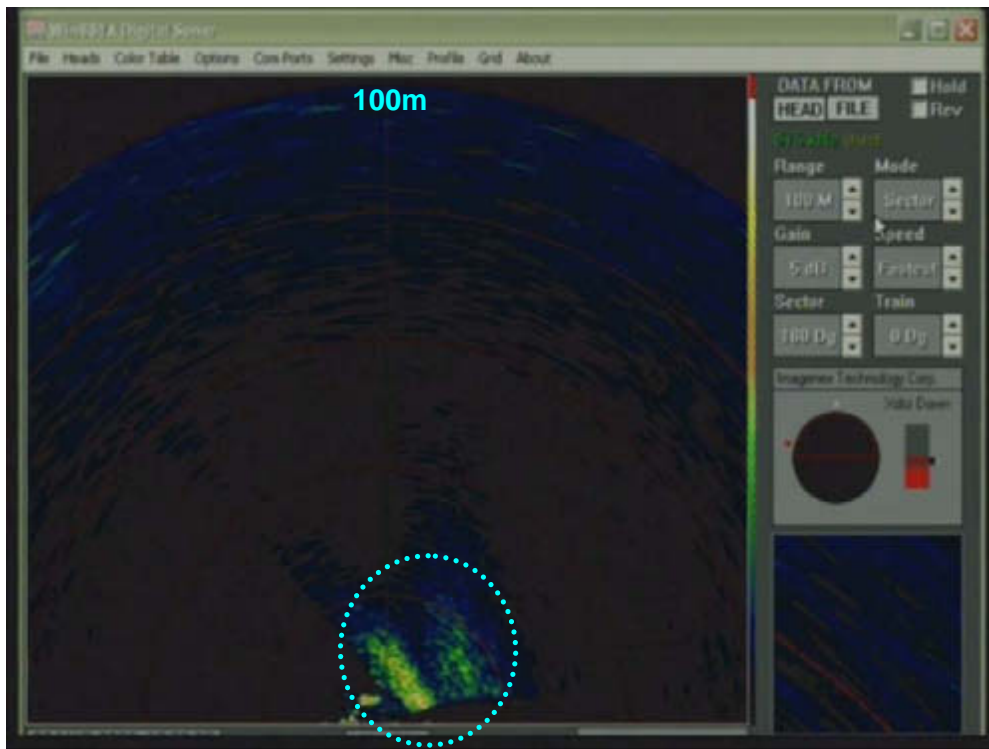
Figure 3.5: Sonar scan on north cardinal bearing at 100m range. A cuttings mound is indicated by the blue circle

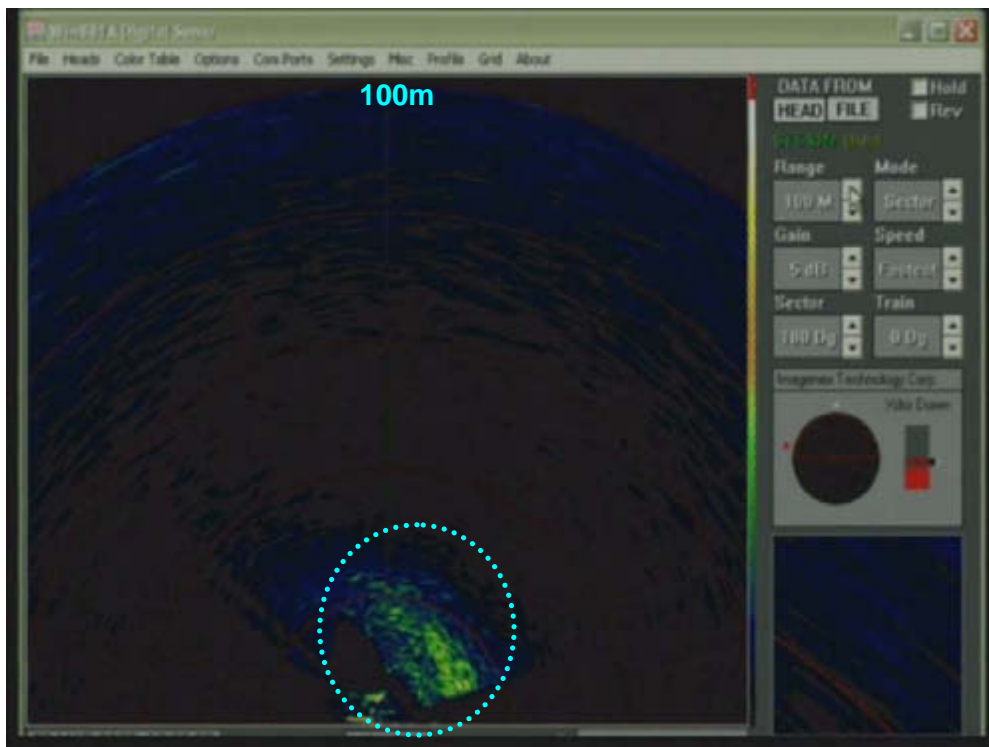
Figure 3.6: Sonar scan on east cardinal bearing at 100m range. A cuttings mound is indicated by the blue circle
